# SYSTEM ANNUAL INSPECTION REPORT Fiscal Year 2023

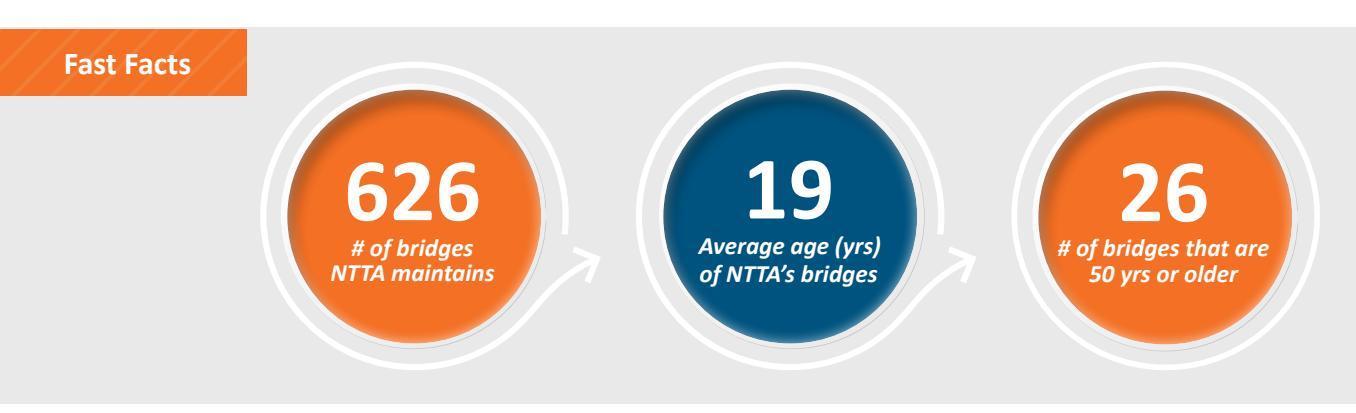
The bridge condition score (BCS) is another performance measure used by TxDOT to assess and communicate the overall health of Texas' bridge inventory. The BCS is calculated based on each bridge's minimum component rating and weighted by the deck area. The overall BCS for bridges in Texas is 88.91. NTTA's bridges have an overall BCS of 91.47.

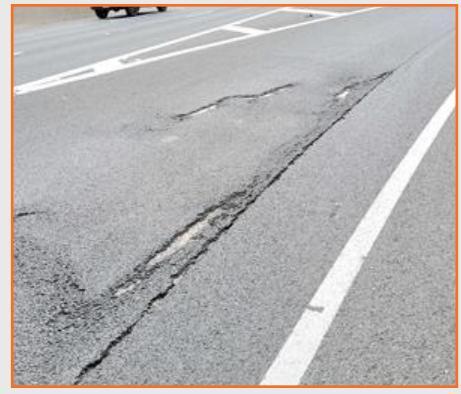
*Figure 2: DNT pavement delamination SBML at IH-635.*

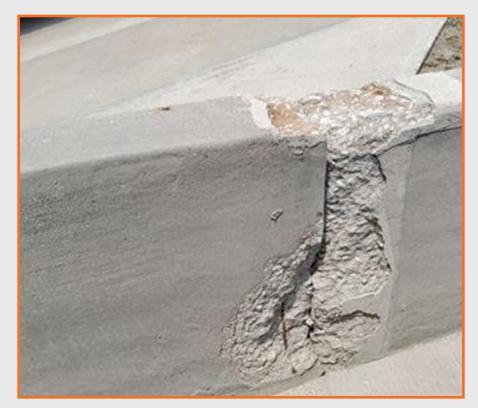
Figure 3: DNT concrete rail damage SBML south of Eldorado Pkwy.

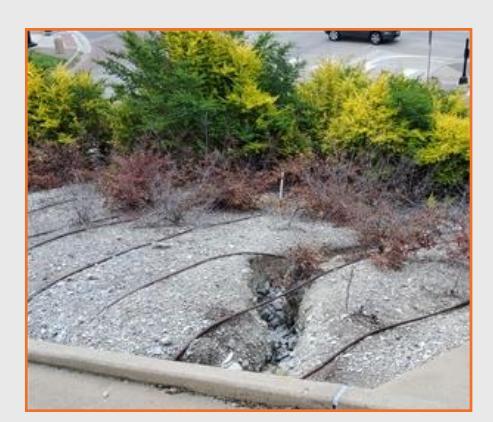
Figure 4: DNT erosion SBML S. of Gaylord Pkwy.

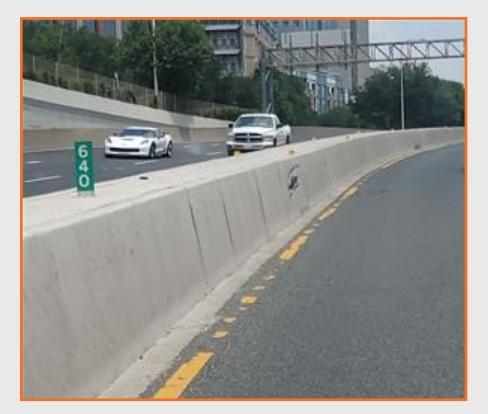
Figure 6: DNT pavement markings faded or missing NBML north of Arapaho Rd.

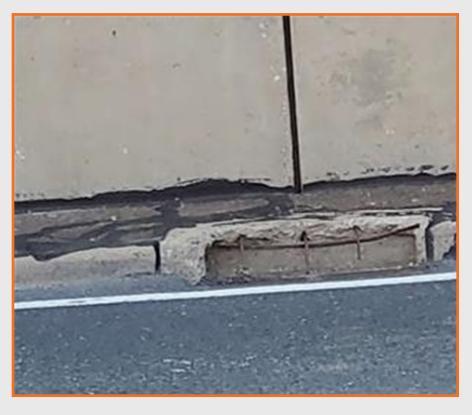
Figure 7: DNT curb inlet damage NBML south of Oak Lawn Ave.

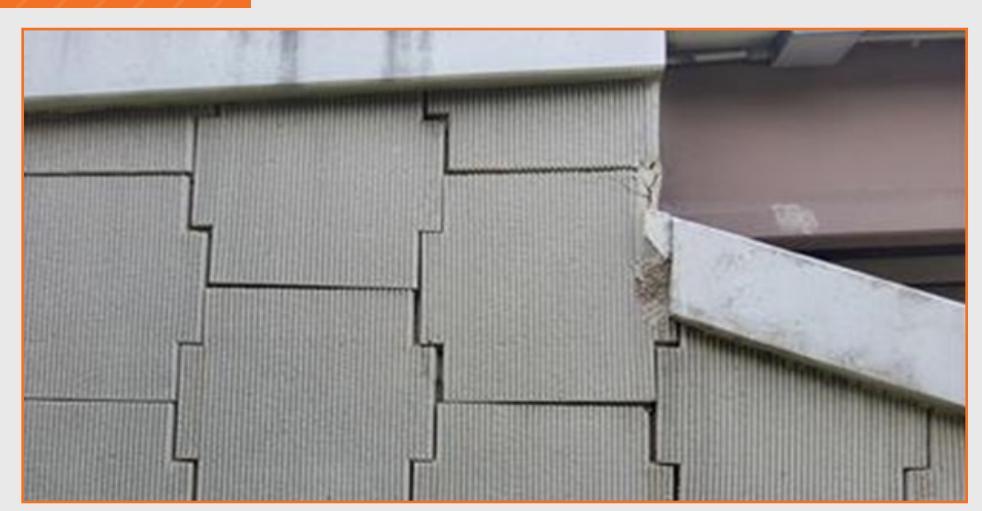
Figure 8: DNT MSE racked wall panels exhibiting cracking and spalling NBML south of IH-635.

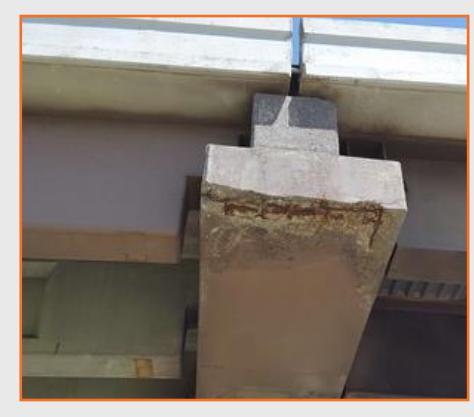
Figure 9: DNT bridge bent cap spalling with exposed reinforcement SBML at IH-635.

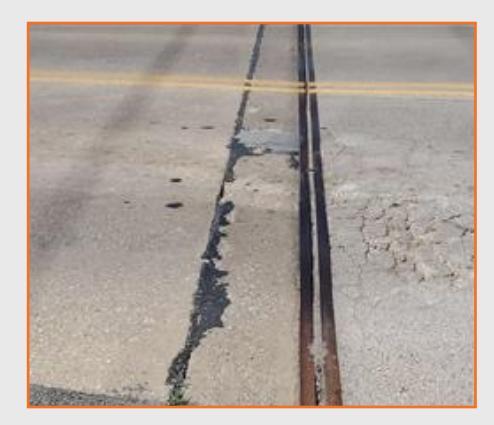
Figure 10: DNT bridge deck deterioration at Northaven Rd.

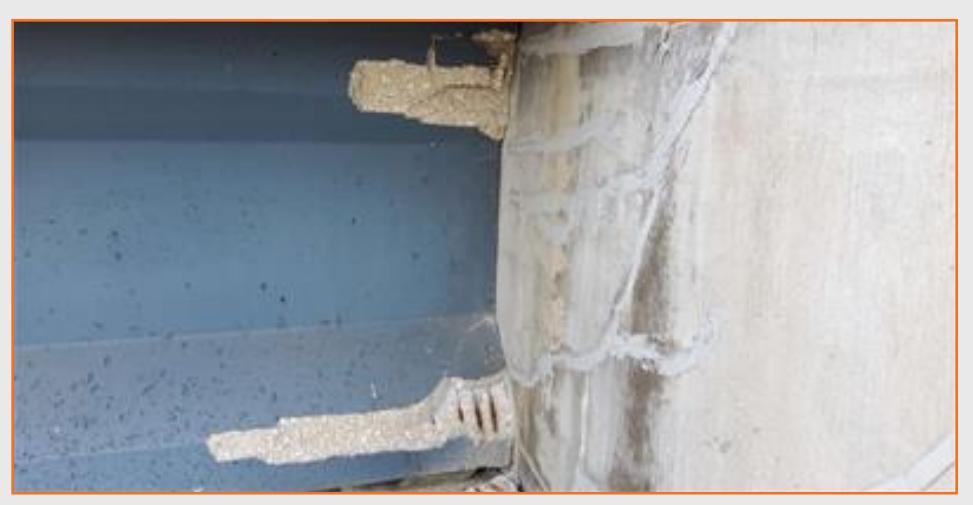
Figure 11: DNT bridge beam spalling with exposed reinforcement SBML at Eldorado Pkwy.

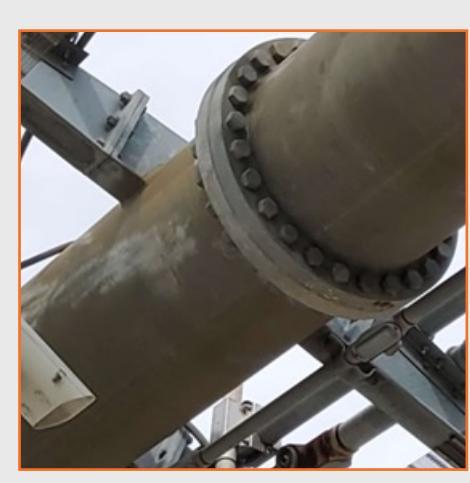
Figure 12: DNT MLG1 gantry corrosion.

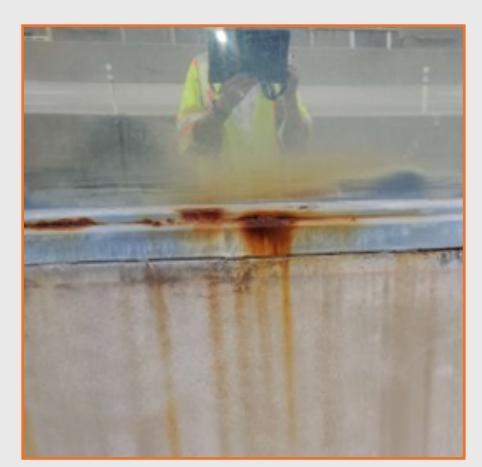
Figure 13: DNT MLG1 rust and paint repair at IT building.

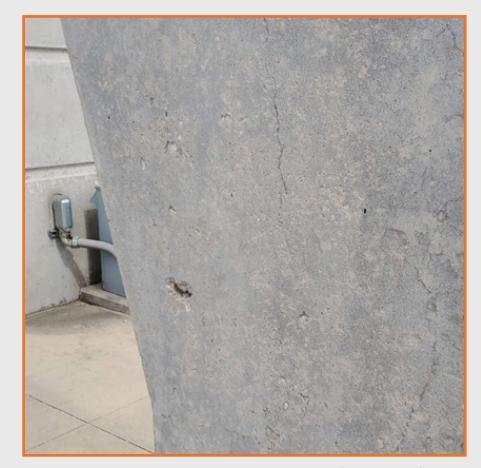
Figure 14: DNT MLG3 minor cracking and chipping at gantry columns.

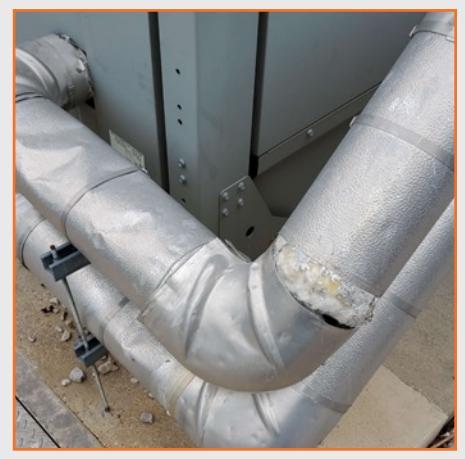
Figure 15: DNT MLP3 duct issues in mechanical yard.

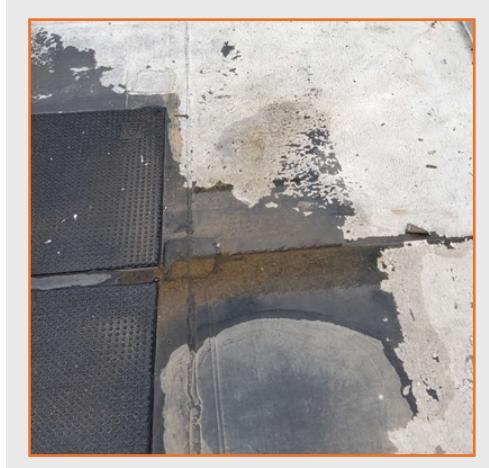
Figure 16: DNT MLP4 roof deterioration.

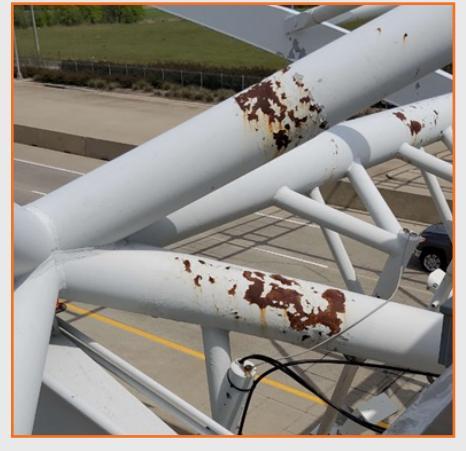
Figure 17: DNT MLP4 coating deterioration on plaza structure.

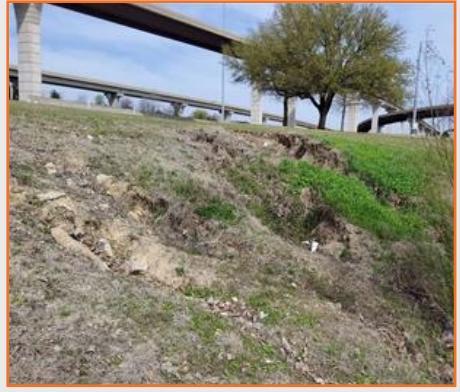
Figure 18: PGBT roadside erosion adjacent to SBML at IH-30 in Garland.

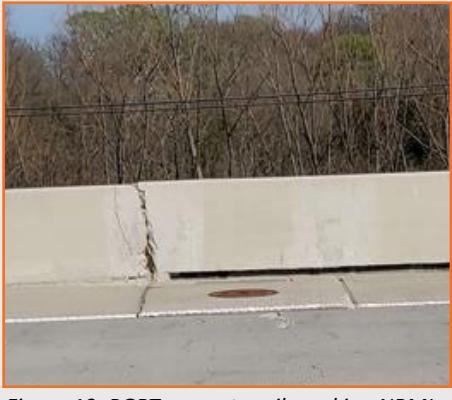
Figure 19: PGBT concrete rail cracking NBML between Miller Rd. and Main St.

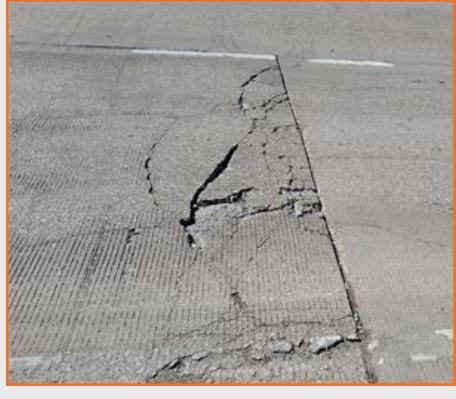
Figure 20: PGBT pavement distress NBFR just north of January Ln.

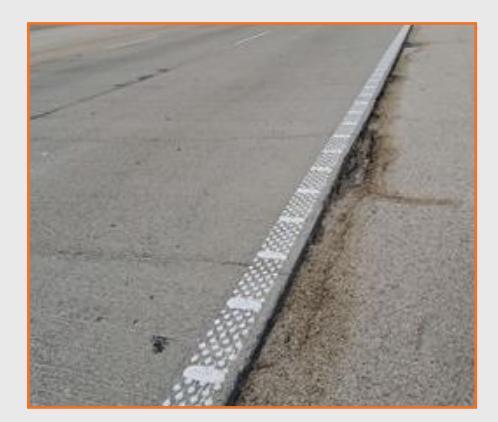
Figure 21: PGBT asphalt shoulder deterioration NBML just south of N. Garland Rd.

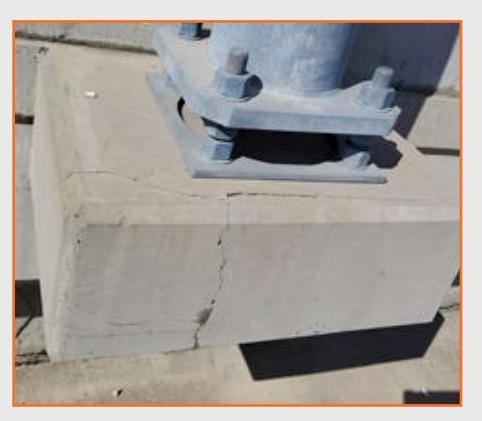
*Figure 22: PGBT light pedestal cracking NBML just north of Pioneer Pkwy.*

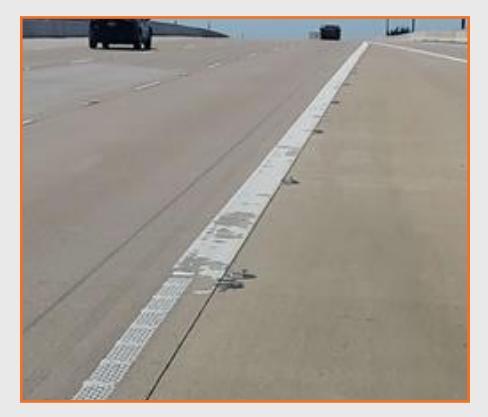
Figure 23: PGBT pavement markings faded or missing SBML north of Pioneer Pkwy.

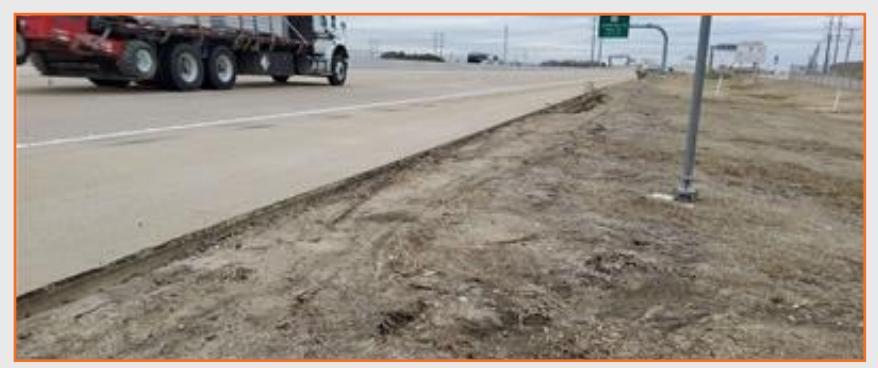
Figure 24: PGBT pavement edge drop-off.

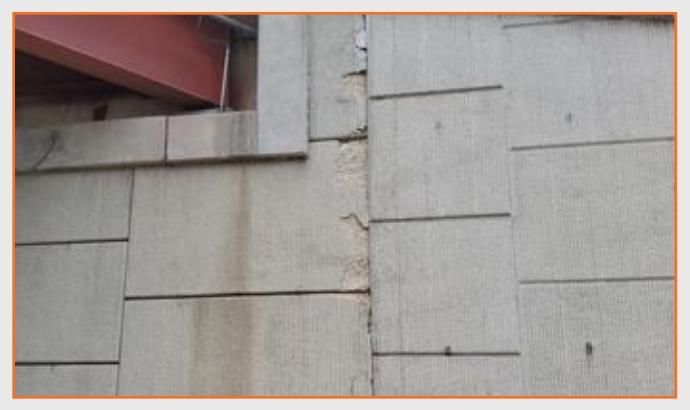
Figure 25: PGBT retaining wall spalls SBML at N. MacArthur Blvd.

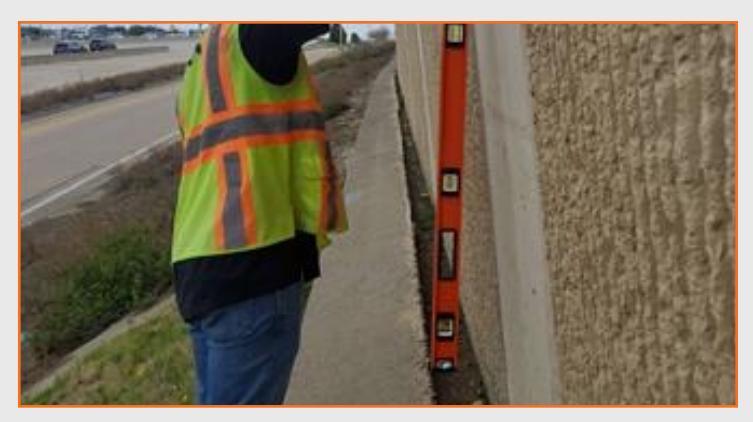
Figure 26: PGBT soundwall movement adjacent to NB exit ramp to Frankford Rd.

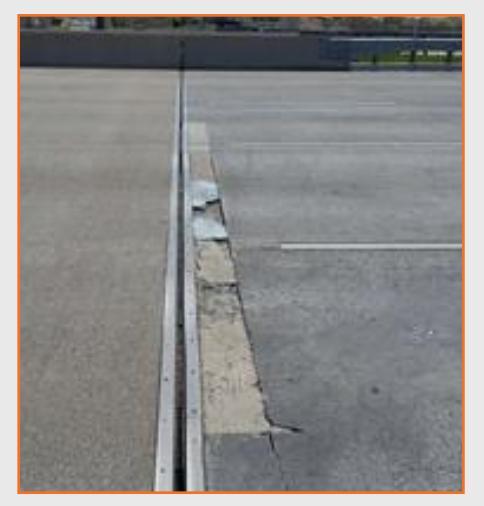
Figure 27: PGBT bridge deck spalling EBML at DNT.

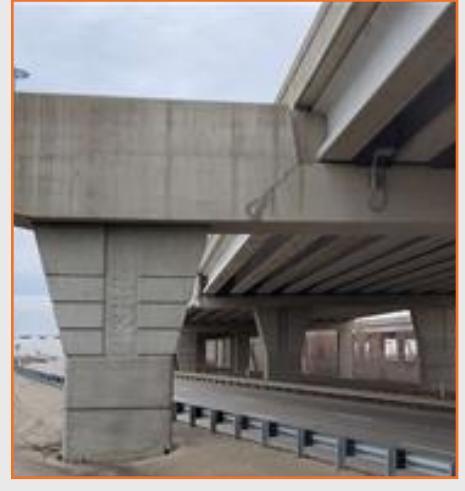
Figure 28: PGBT bridge bent cap cracking SBML south of S Forum Dr.

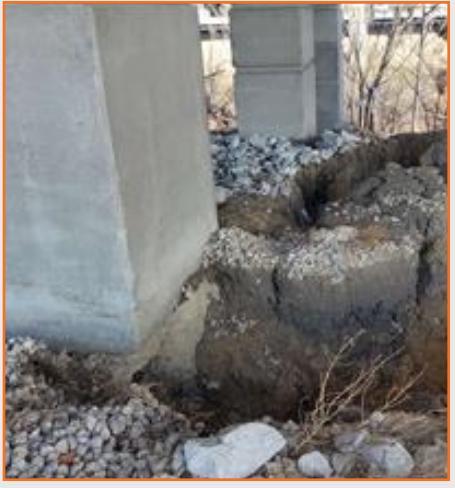
Figure 29: PGBT under bridge erosion SBML south of S Forum Dr.

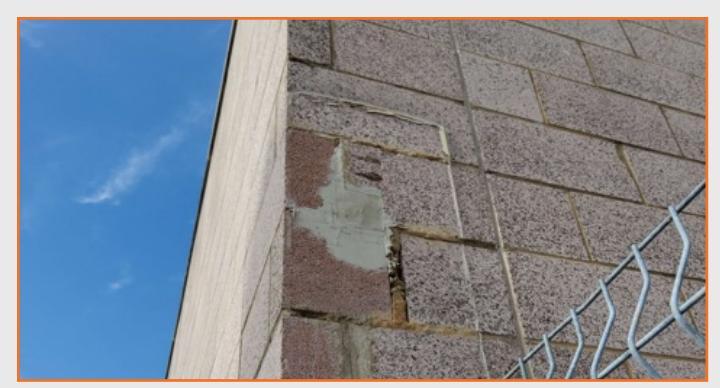
Figure 30: PGBT MLP7 deteriorated masonry joints.

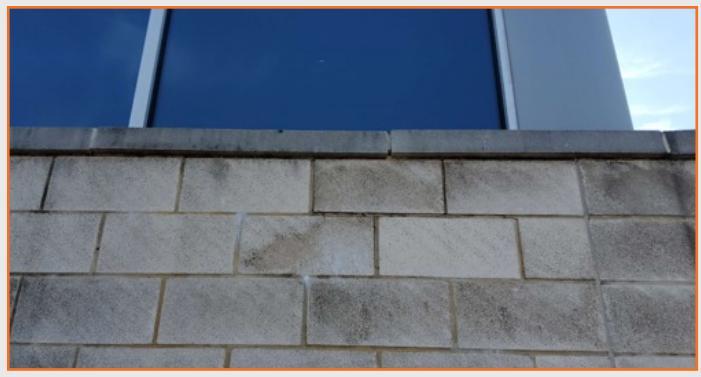
Figure 31: PGBT MLP7 masonry sealant and joint treatments past expected life-cycle.

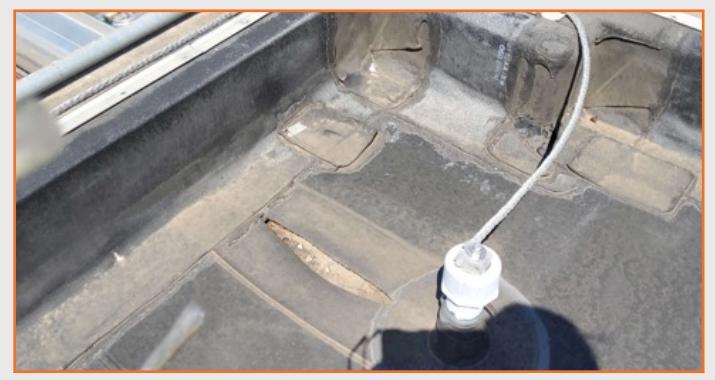
Figure 32: PGBT MLG6 gantry roof deterioration.

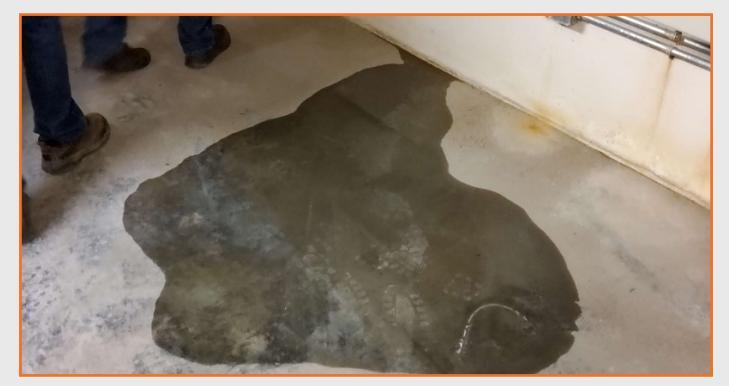
Figure 33: PGBT MLP6 tunnel leaks.

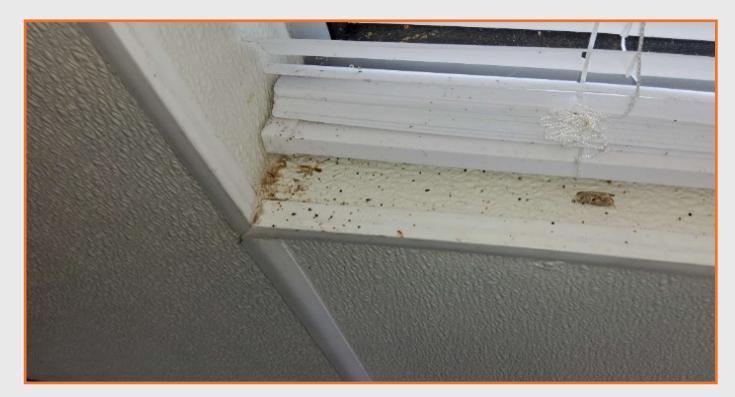
Figure 34: PGBT MLG12 pest control at Fiber Hut.

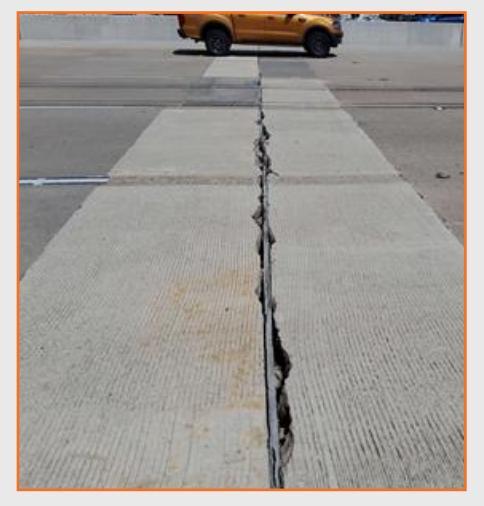
Figure 35: SRT concrete pavement joint deterioration NBML north of Old Denton Rd.

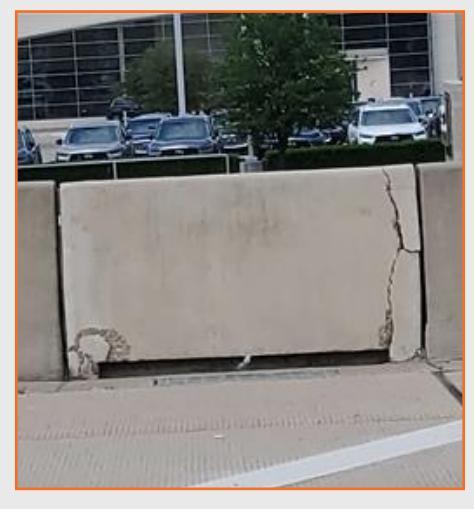
Figure 36: SRT concrete rail cracking and spalling SBML north of Leadership Dr.

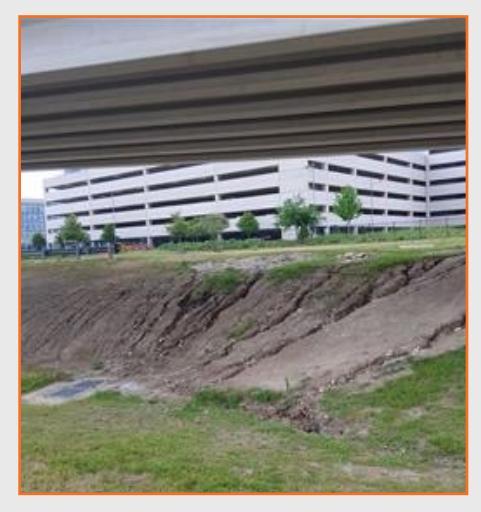
Figure 37: SRT embankment erosion NBML south of DNT.

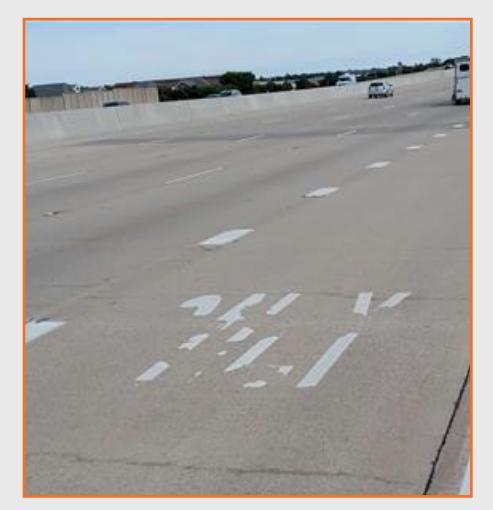
Figure 38: SRT pavement markings faded or missing NBML south of W Hebron Pkwy.

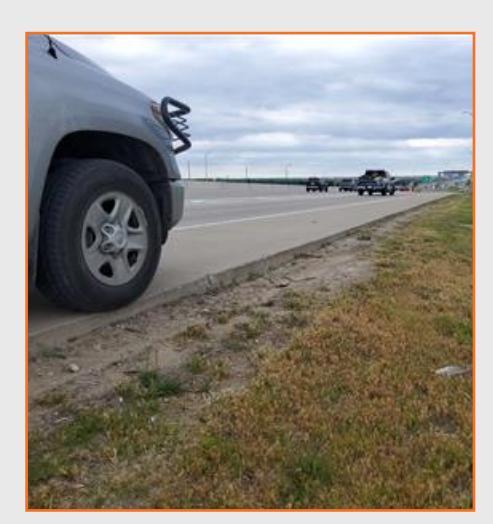
Figure 39: SRT pavement edge drop-off.

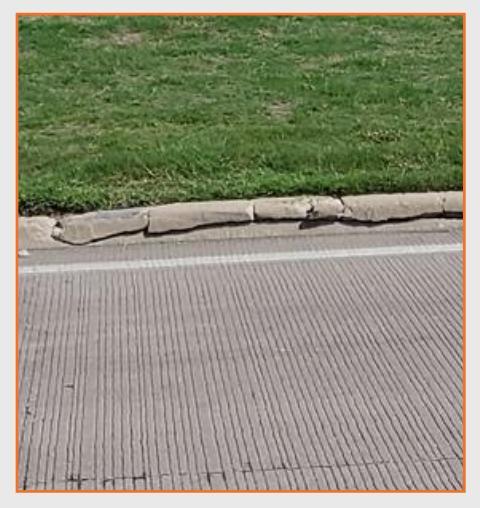
Figure 40: SRT curb damage SBFR south of W. Exchange Pkwy.

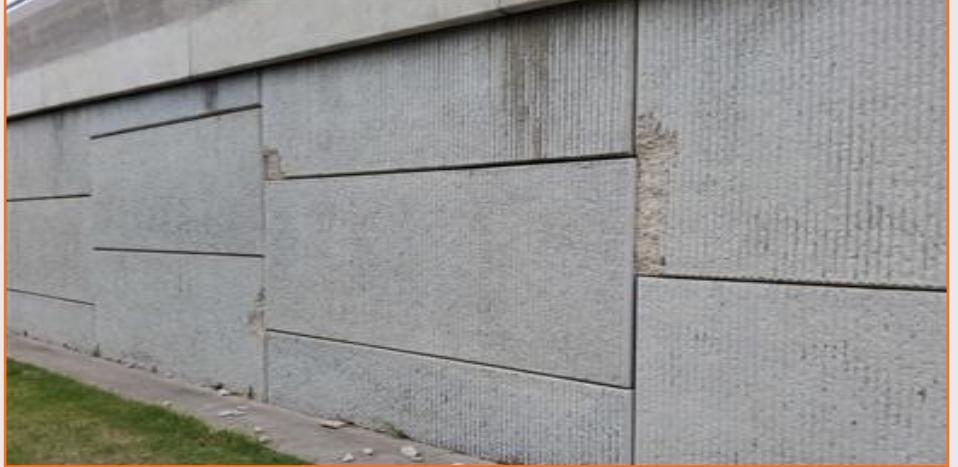
Figure 41: SRT retaining wall spalling SBFR at Ohio Dr.

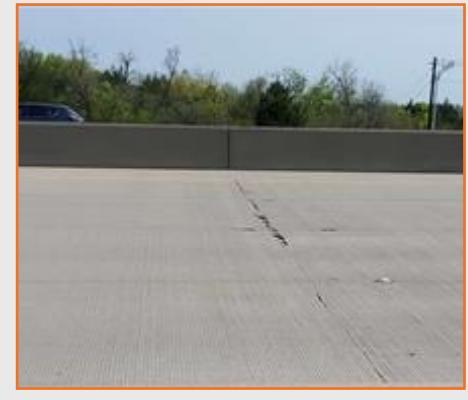
Figure 42: SRT bridge deck distress SBML north of S Lake Forest Dr.

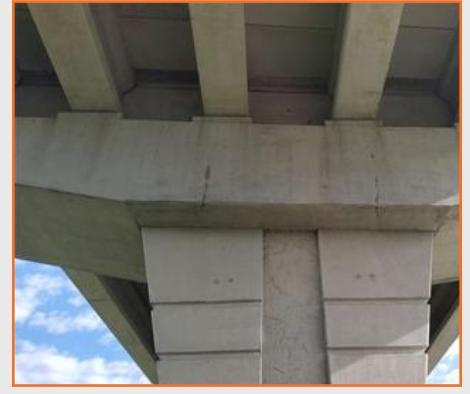
Figure 43: SRT bridge bent cracking SRT DC at UŠ-75.

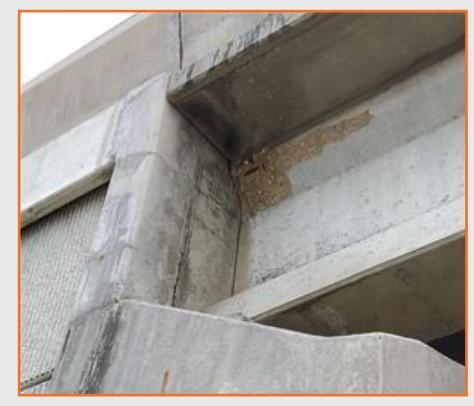
Figure 44: SRT bridge beam with exposed reinforcement at Ohio Dr.

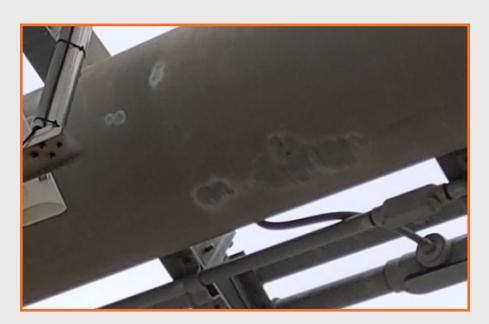
*Figure 46: SRT MLG2 corrosion at gantry structure.*

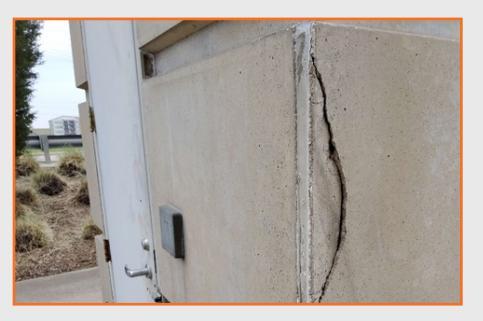
Figure 47: SRT MLG3 wall damage at IT building.

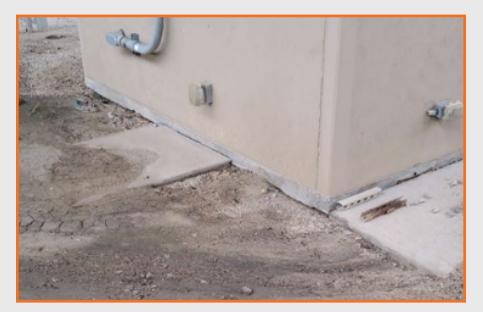
Figure 48: SRT Fiber Hut drainage concern and undermining of building.

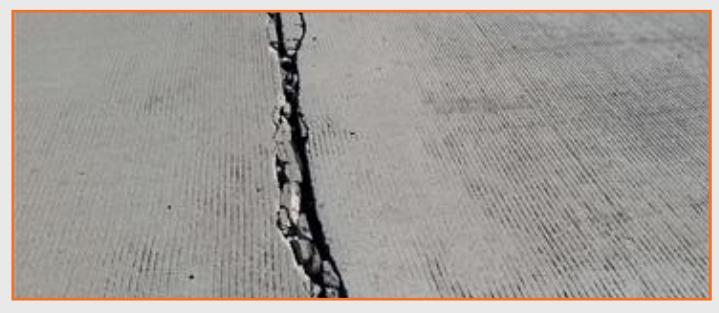
Figure 49: CTP concrete pavement joint deterioration SBML north of Arborlawn Dr.

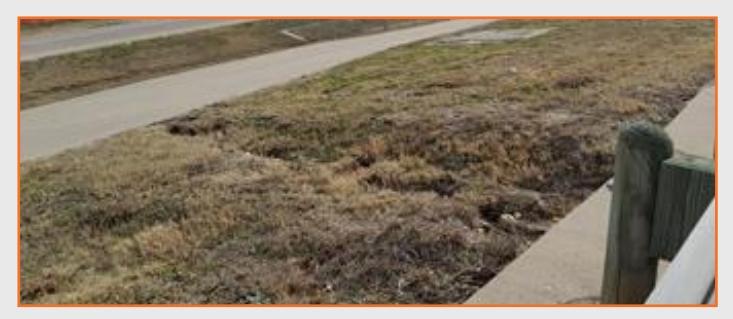
Figure 51: CTP embankment erosion NBML south of Sparks Dr.

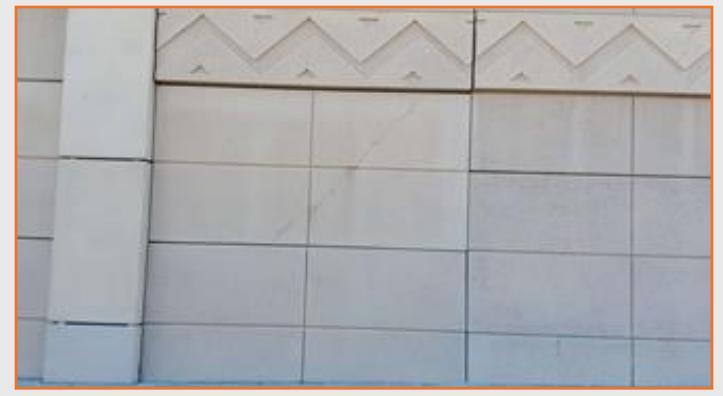
Figure 53: CTP MSE retaining wall panel cracking NBML north of Southwest Blvd.

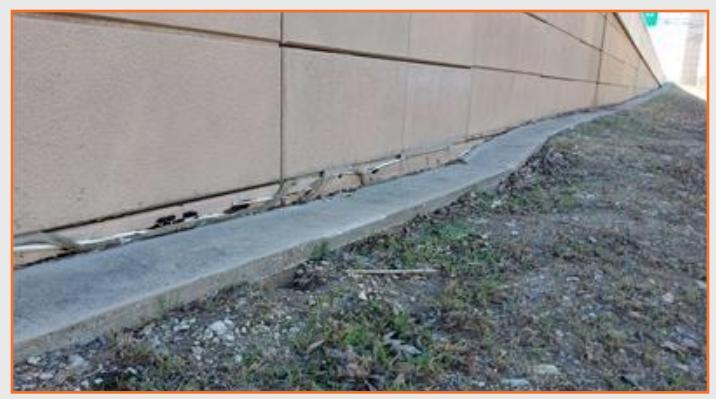
Figure 54: CTP MSE racked panels and wall mow strip settlement SBML adjacent to UPRR Rail Yard.

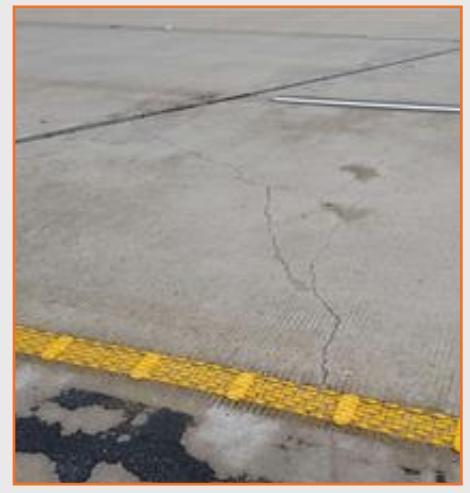
Figure 55: CTP approach slab cracking NBML south of Overton Ridge Blvd.

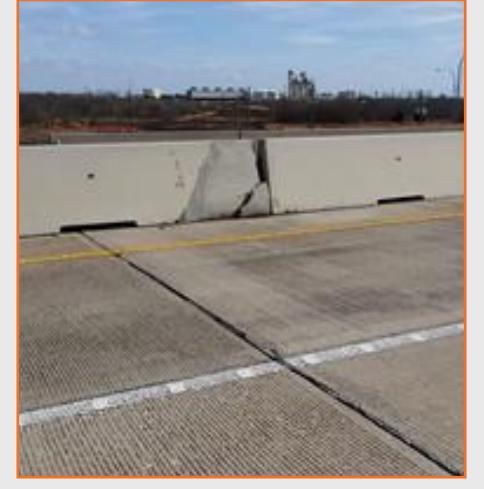
Figure 56: CTP bridge rail spalling SBML at Sparks Dr.

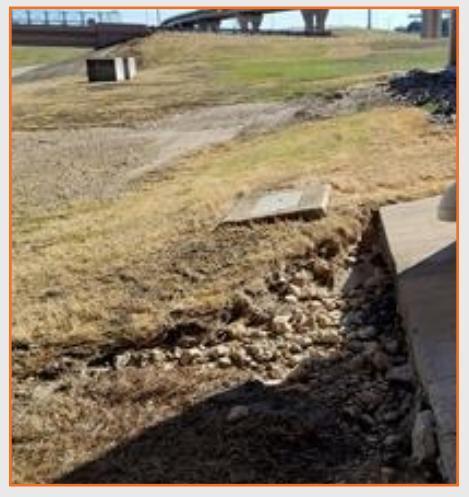
Figure 57: CTP erosion NBML at IH-20.

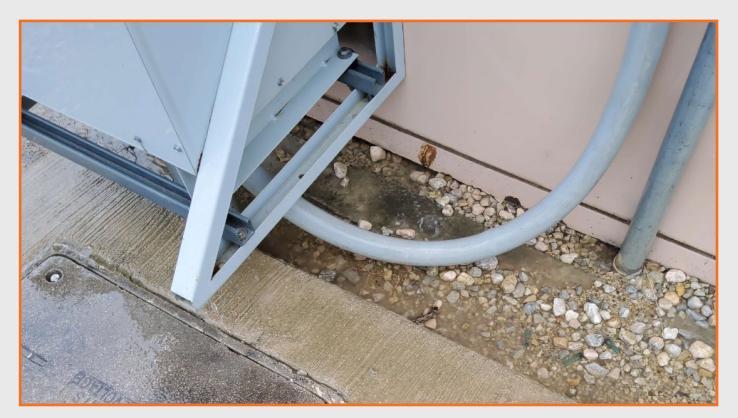
Figure 58: CTP Fiber Hut at FM 1187 runoff entering building.

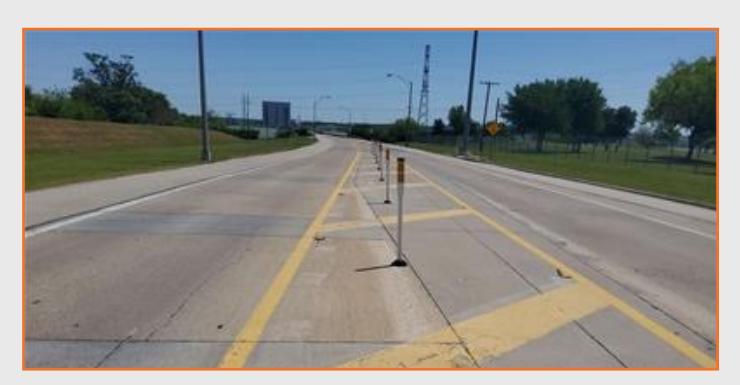
Figure 60: MCLB pavement markings faded or missing.

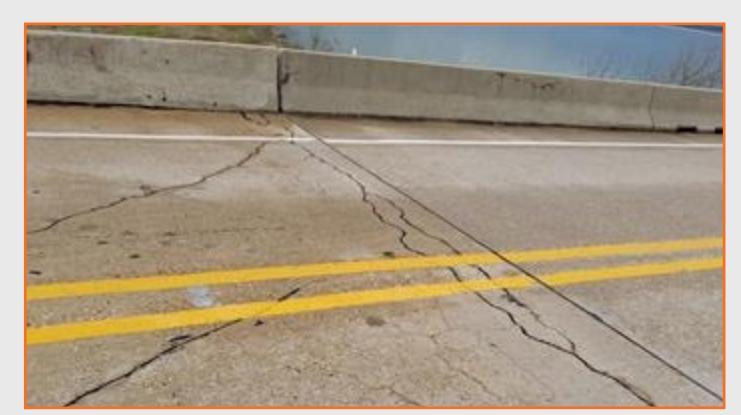
Figure 61: MCLB approach slab cracking.

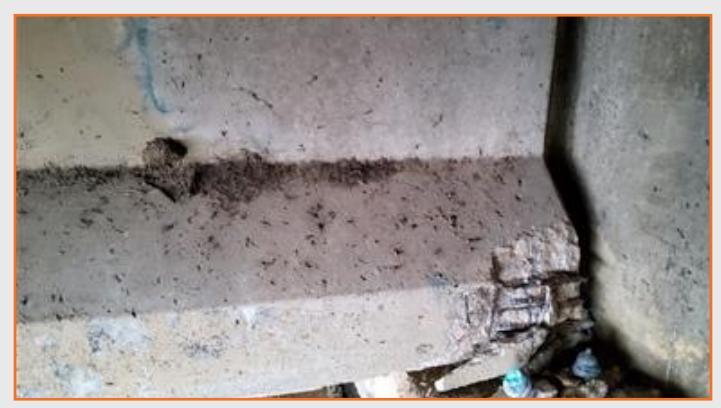
Figure 62: MCLB beam spalling with reinforcement exposed.

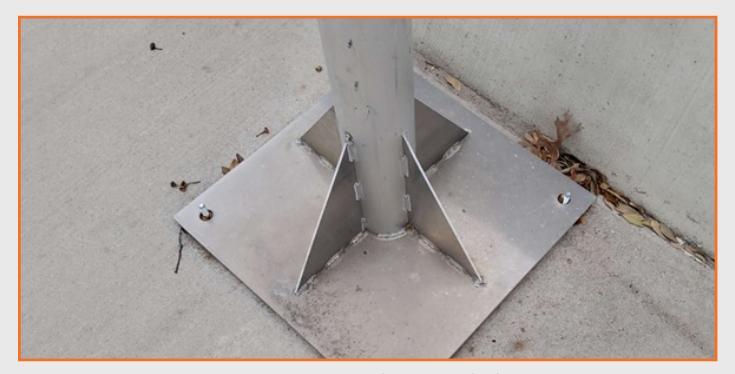
Figure 63: MCLB gantry camera stand missing bolts.

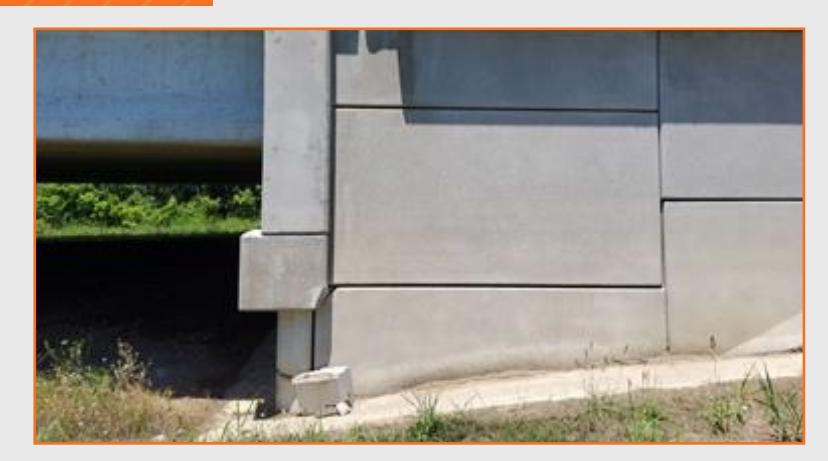
Figure 64: LLTB coping damage.

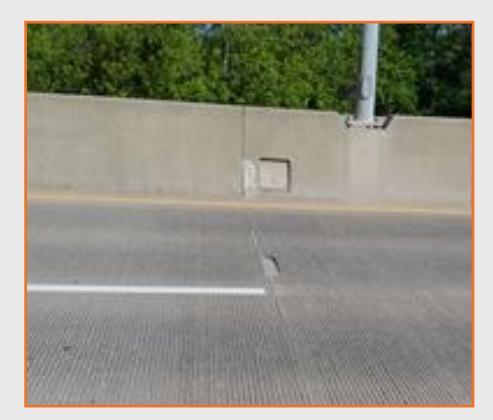
Figure 65: LLTB bridge deck spalling EBML.

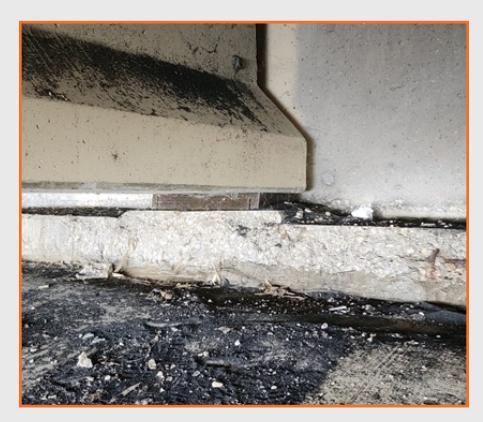
Figure 66: LLTB bridge abutment spalling with reinforcement exposed.

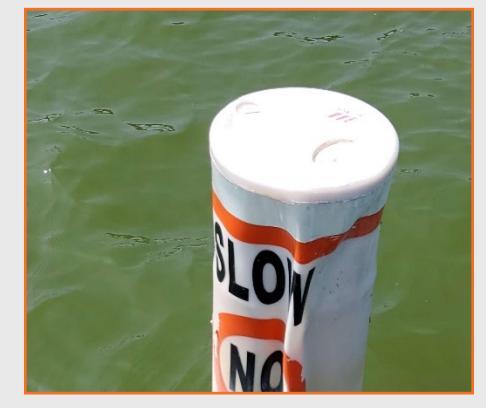
Figure 68: LLTB buoy damage.

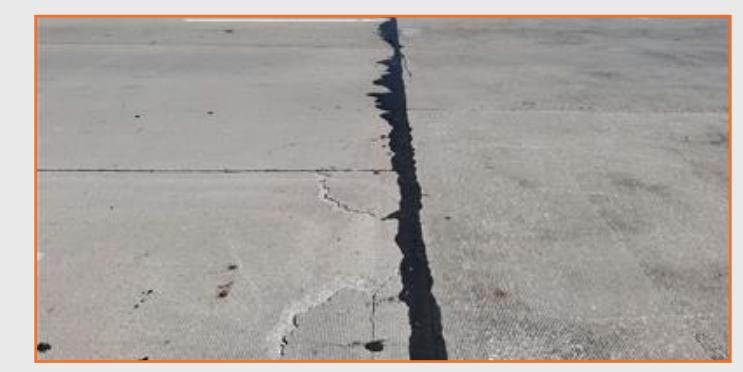
Figure 69: AATT concrete pavement distress.

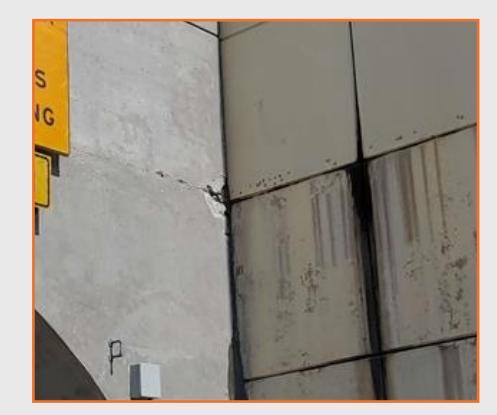
Figure 70: AATT CIP wall cracking and spalling.

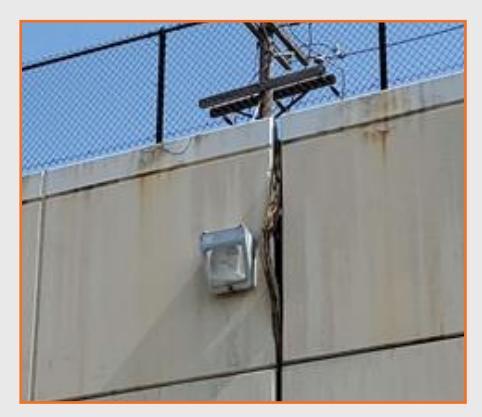
Figure 71: AATT MSE wall panel joint seal damaged/missing.

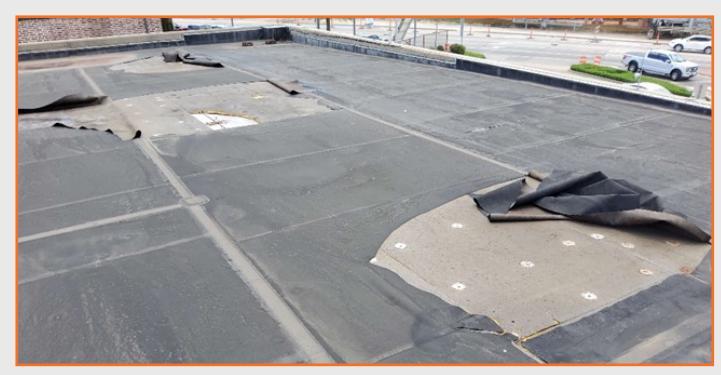
Figure 72: AATT roofing membrane damage.

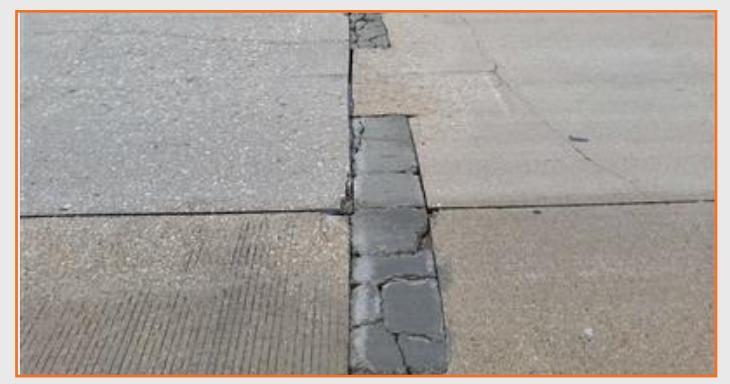
Figure 73: 360T concrete pavement distresses NBFR near Doryn Dr.

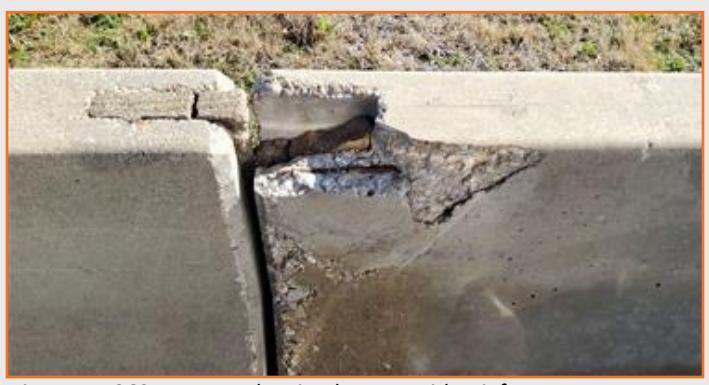
Figure 74: 360T concrete barrier damage with reinforcement exposed SBML south of SE Green Oaks Blvd.

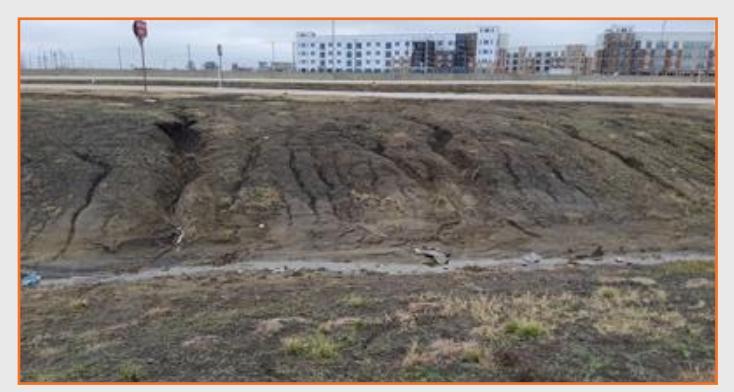
Figure 75: 360T embankment erosion between NB mainlanes and frontage road near Heritage Pkwy.

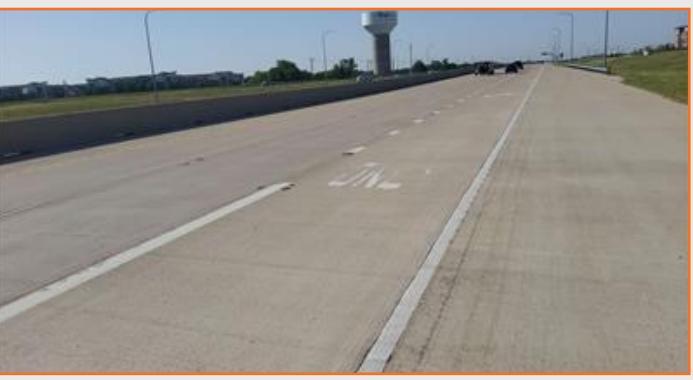
Figure 77: 360T pavement markings faded or missing SBML at Ragland Rd.

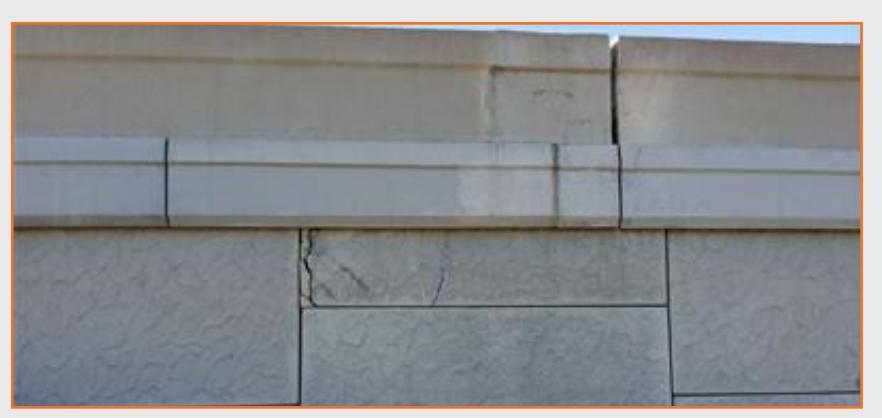
Figure 78: 360T MSE wall panel cracking and spalling NBML north of FM 2011.

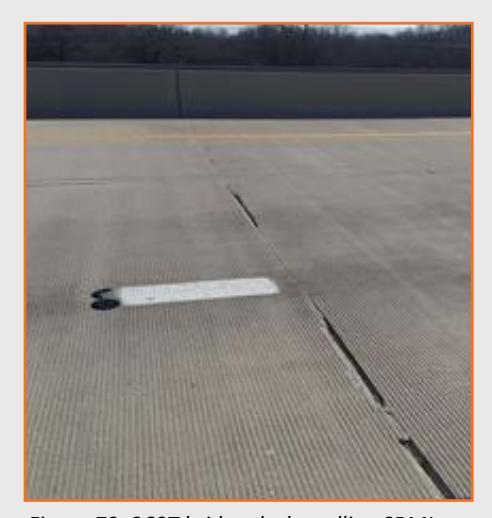
Figure 79: 360T bridge deck spalling SBML north of N Holland Rd.

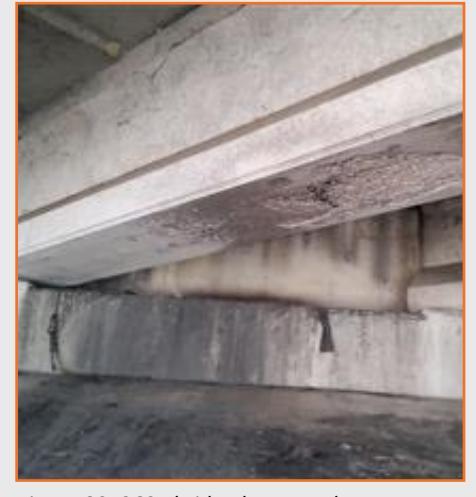
Figure 80: 360T bridge beam and concrete riprap spalling at SE Green Oaks Blvd.

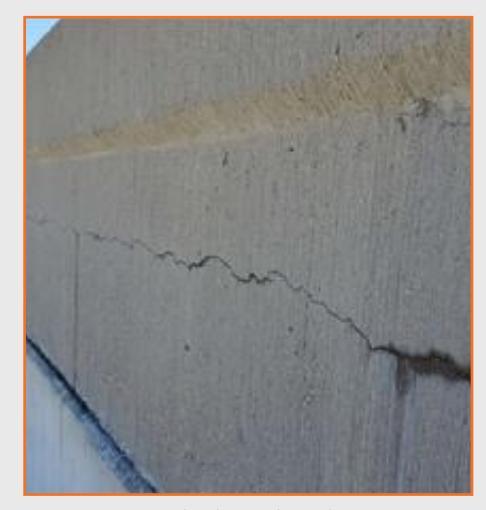
*Figure 81: 360T bridge rail cracking NBML south of Heritage Pkwy.*

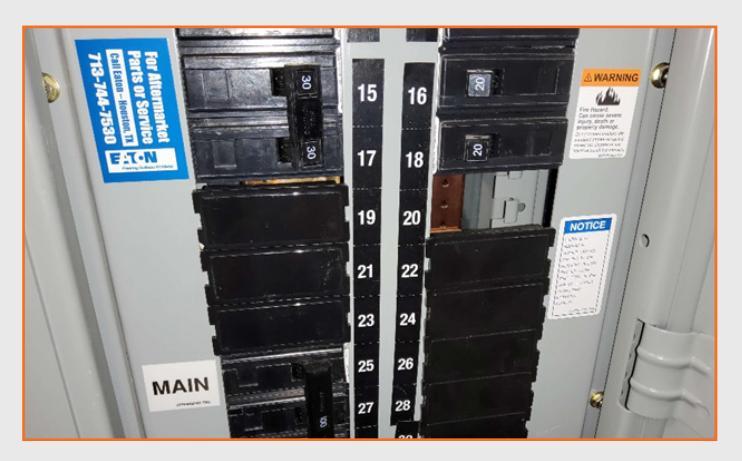
Figure 82: Panel board missing schedule.

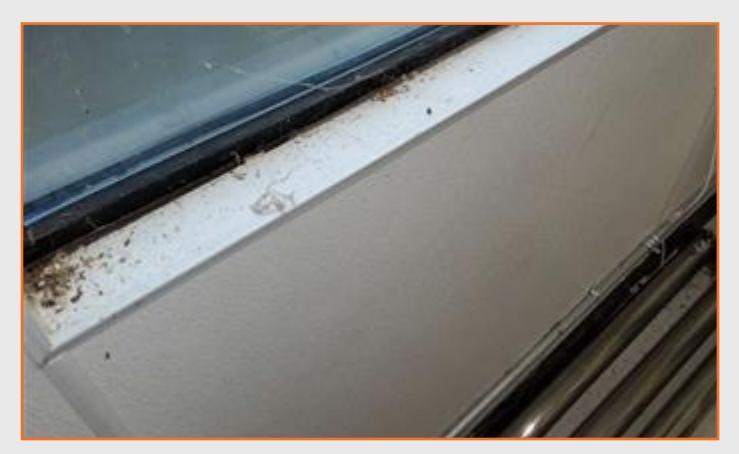
Figure 83: 360T Fiber Hut pest infestation.

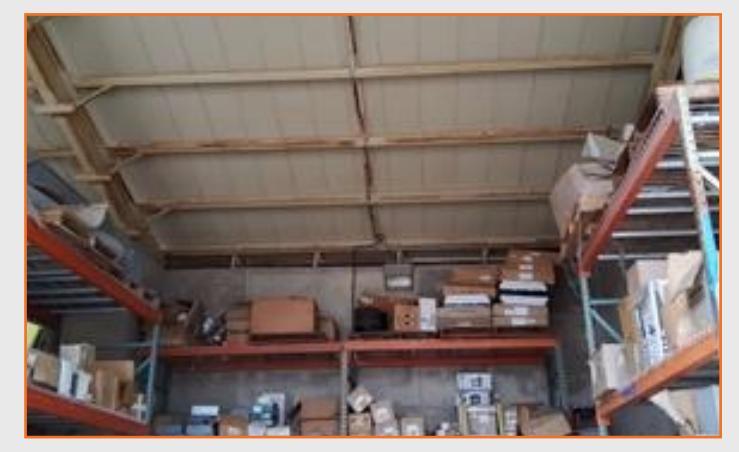
Figure 84: Plano Operations Center rust on steel frame of storage facility.

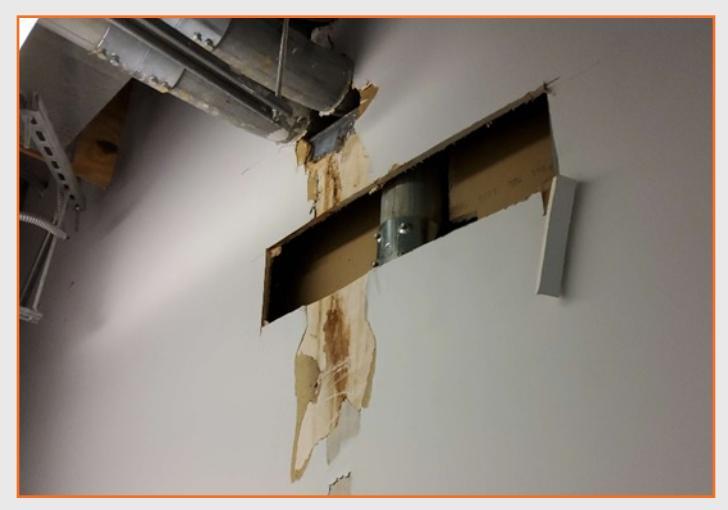
Figure 85: Frisco Operations Center gypsum board removed due to water infiltration at several locations.

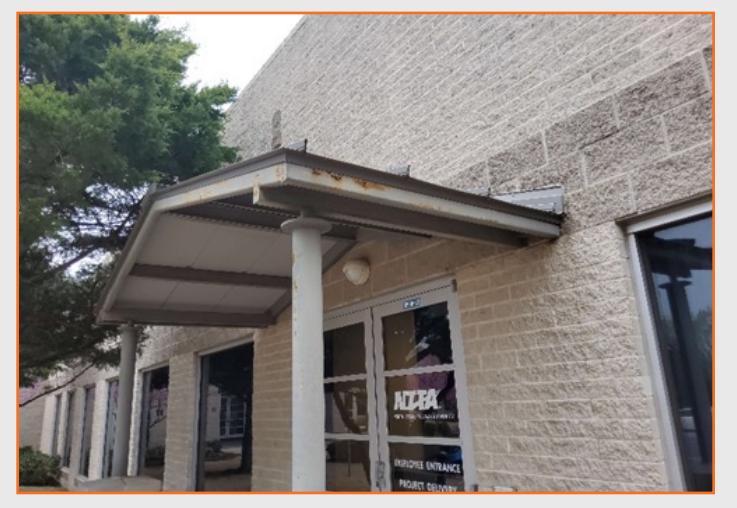
Figure 86: Gleneagles Office Complex ferrous metal coating failure.

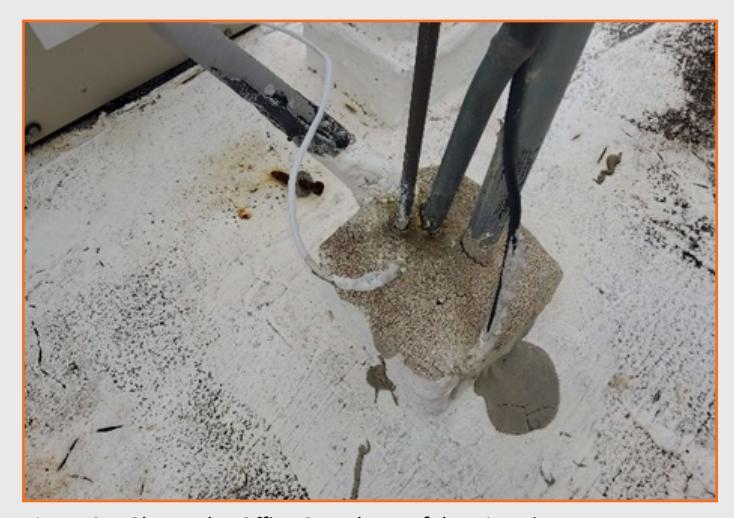
Figure 87: Gleneagles Office Complex roof deterioration.
