# SYSTEM ANNUAL INSPECTION REPORT Fiscal Year 2023

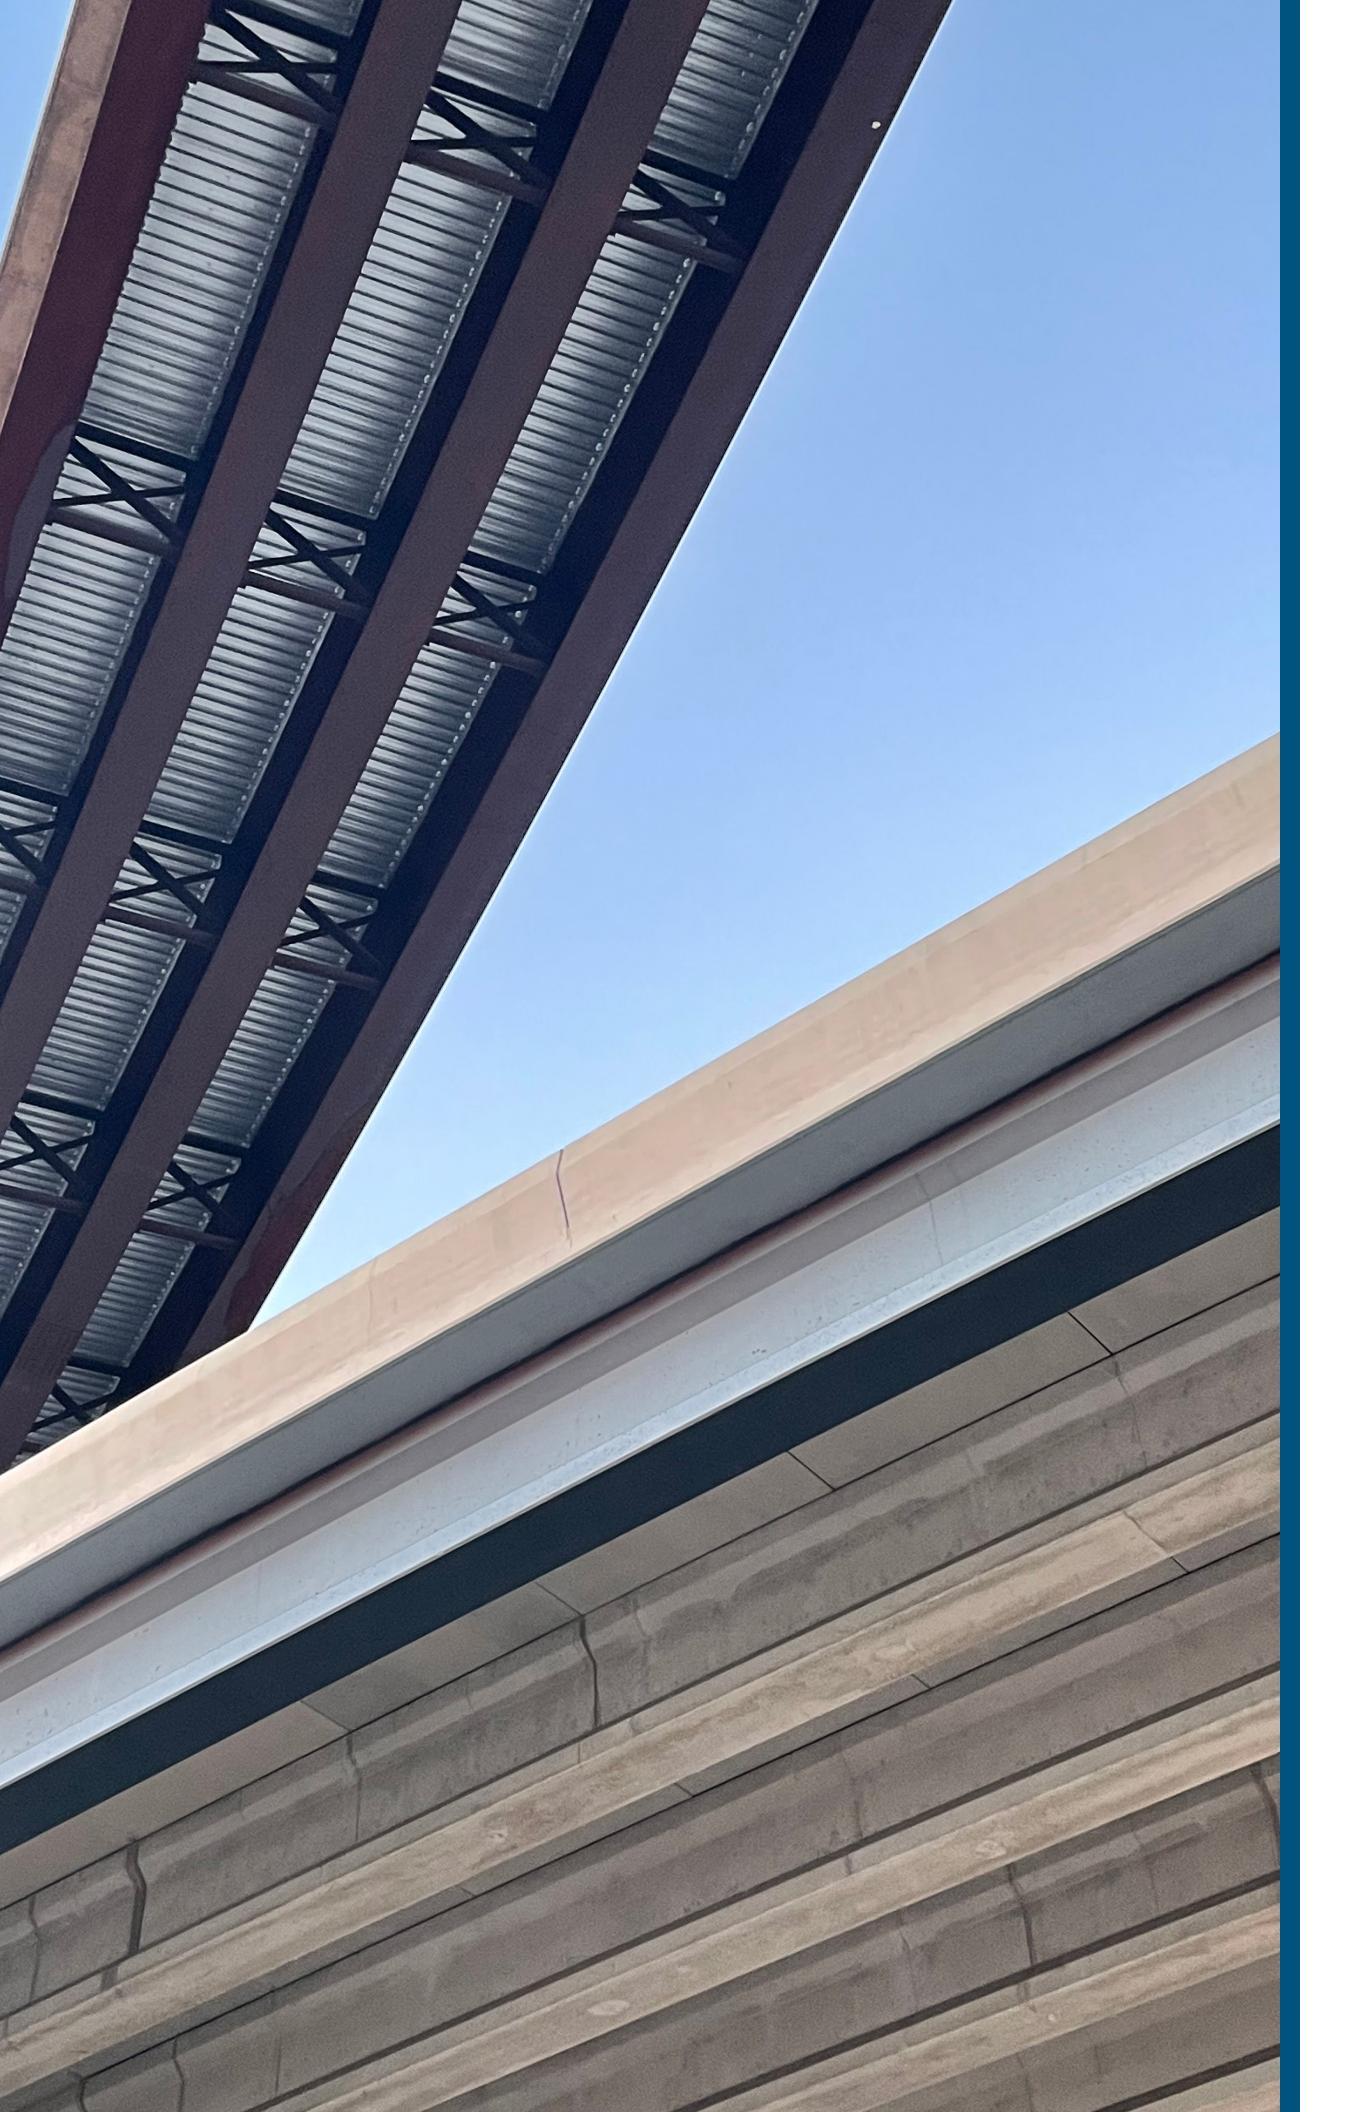
# RESTATED TRUST AGREEMENT APPENDIX A - SECTION 504 OF THE AMENDED AND

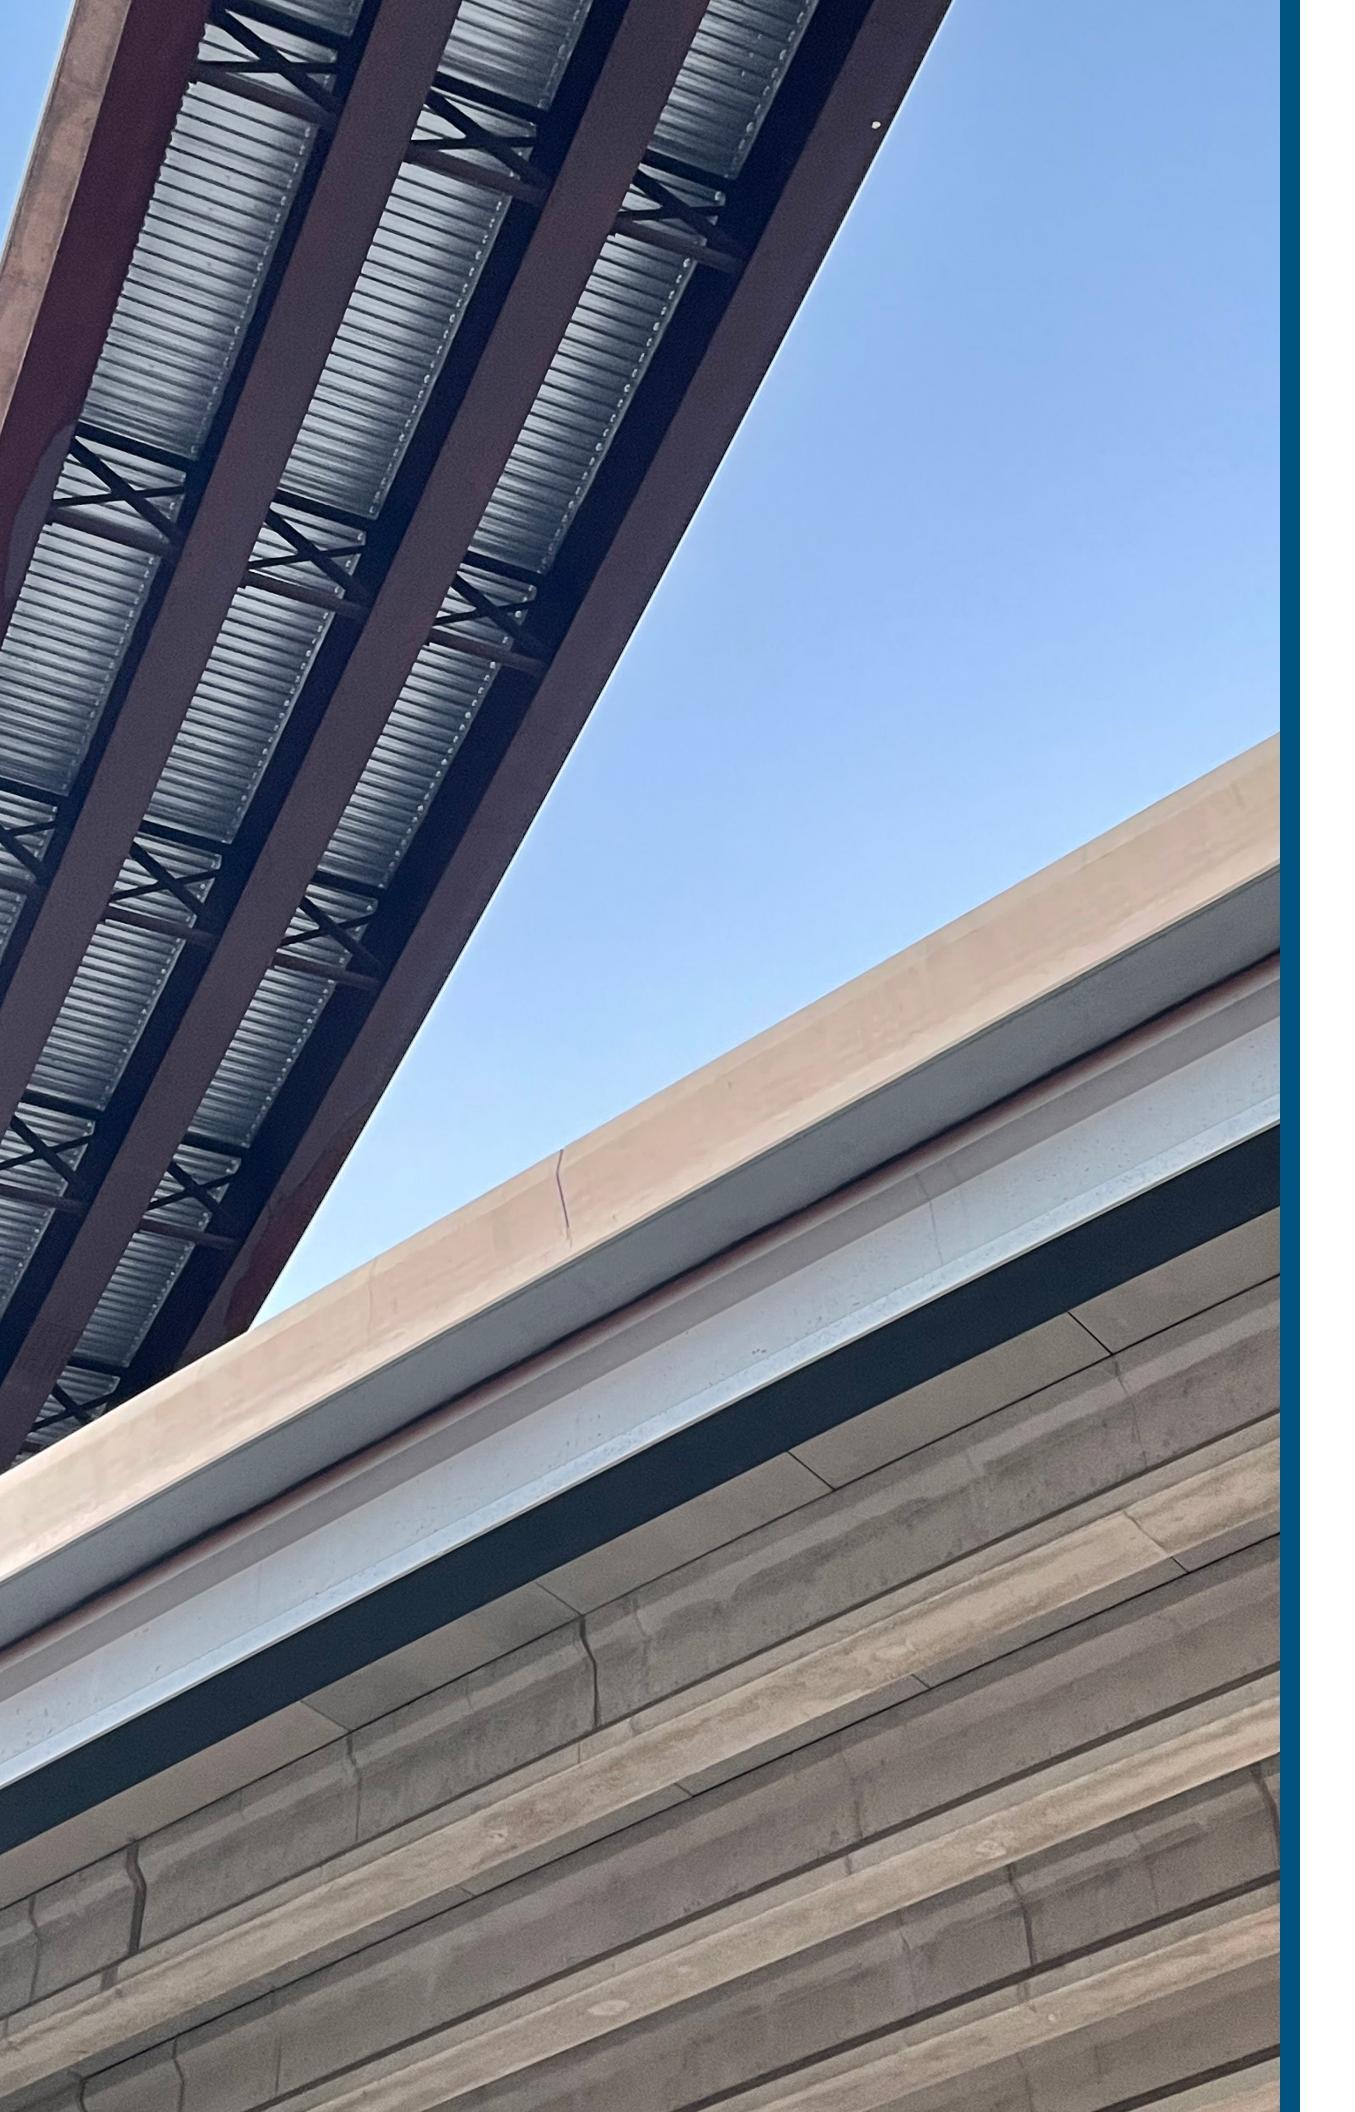
If the holders of at least five percent (5%) in aggregate principal amount of the bonds then Outstanding shall so request in writing on or before the 60th day prior to the end of any Fiscal Year, the Authority shall hold a public hearing on or before the 30th day prior to the end of such Fiscal Year at which any bondholder may appear in person or by agent or attorney and present any objections he may have to the final adoption of such budget. Notice of the time and place of such hearing shall be mailed, at least ten (10) days before the date fixed by the Authority for the hearing, to the Trustee, the Consulting Engineers, and each bondholder who shall have filed his name and address with the Board Representative designated for such purpose, which shall initially be the Chief Financial Officer of the Authority. The Authority further covenants
