Report for 360 TOLLWAY

September 2020

As General Engineering Consultant to the North Texas Tollway Authority and in accordance with the requirements set forth in the NTTA System Amended and Restated Trust Agreement Section 504, Atkins North America, Inc. (Atkins) is pleased to submit the Fiscal Year 20 (FY20) Annual Inspection Report for the 360 Tollway.

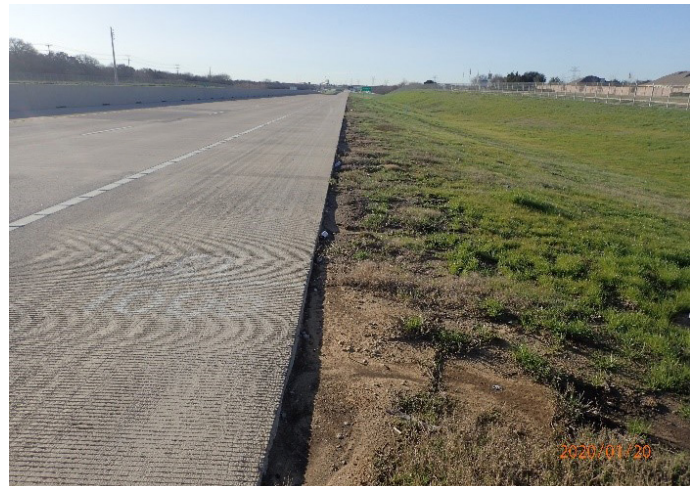
Figure 2: Pavement Edge Drop-off

Pavement edge drop-off were observed at various locations throughout the corridor as illustrated in Figure 2. There were multiple areas of pavement spalling as illustrated in Figure 3 and one area that had asphalt pavement delamination as shown in Figure 4.

The findings presented in this report as well as a comprehensive listing of findings delivered to the NTTA Maintenance Department will be submitted to TxDOT to address with the contractor under the Comprehensive Maintenance Agreement.

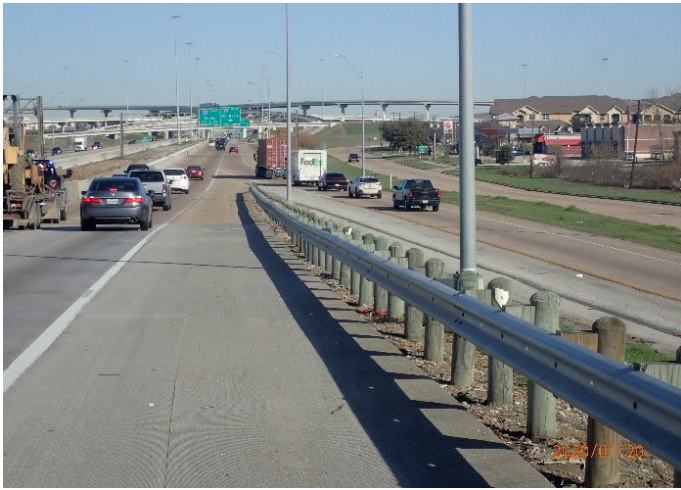
Figure 5: Delineation Missing on Guardrail

There was one area on the metal beam guardrail where the delineation was missing (Figure 5). There were several areas of ditch line erosion (Figure 6).

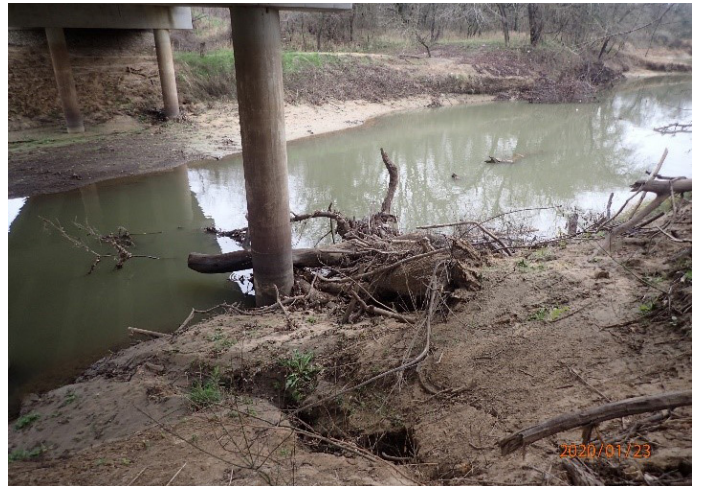
Figure 8: Debris Against Column at Walnut Creek Bridge

There was also noted an area where debris was building up against the bridge column (Figure 8).

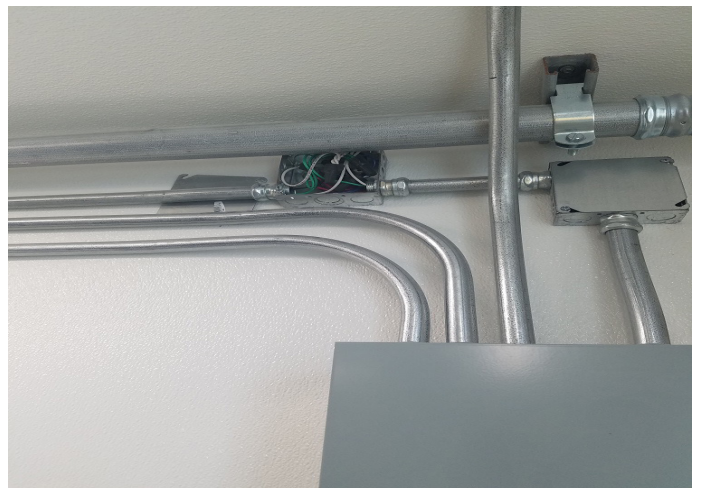
Figure 9: Cover Missing on Junction Box

There are 2 Mainlane Gantry (MLG) facilities on the 360T. MLG 14 is located just north of New York Avenue and MLG 15 is located south of Heritage Parkway. One observation noted was a cover plate missing from the electrical junction box at MLG 15 as noted in Figure 9.

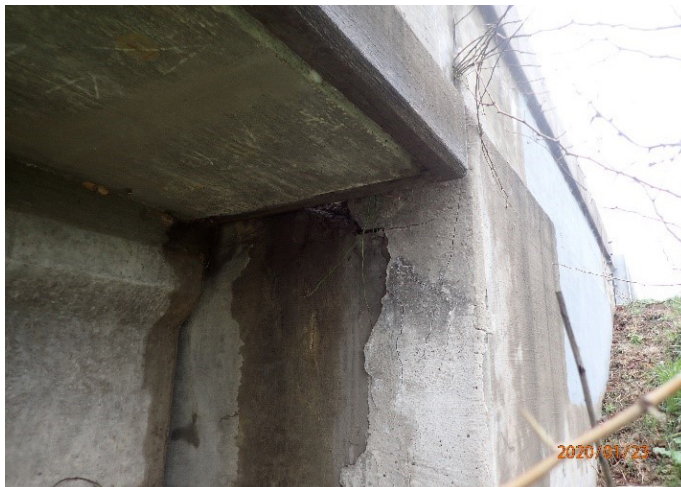
Figure 7: Backwall Cracking at Walnut Creek Bridge

One observation noted was areas of backwall cracking as illustrated in Figure 7.
