# ANNUAL INSPECTION REPORT

## 360 TOLLWAY

Fiscal Year 2019

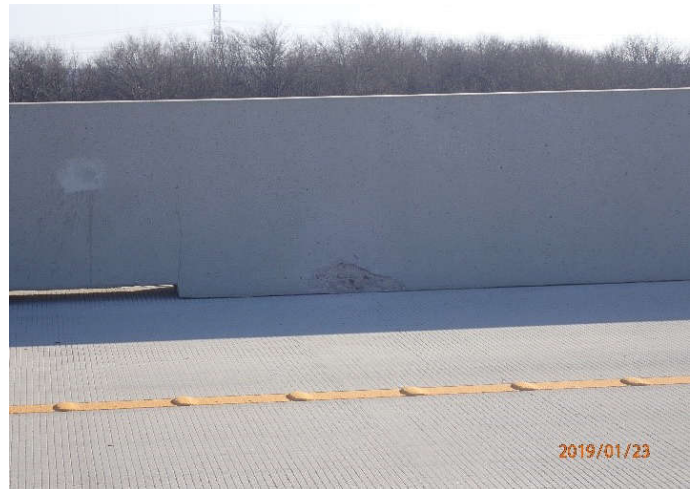
Minor barrier spalling was observed at various locations throughout the corridor as illustrated in Figure 2. There were multiple areas of erosion around riprap and landscape areas as illustrated in Figure 3.

Figure 2: Barrier Rail Spall at SB 360 South of Tarrant County Line

The findings presented in this report as well as a comprehensive listing of findings delivered to the NTTA Maintenance Department will be submitted to TxDOT to address with the contractor under the Comprehensive Maintenance Agreement.

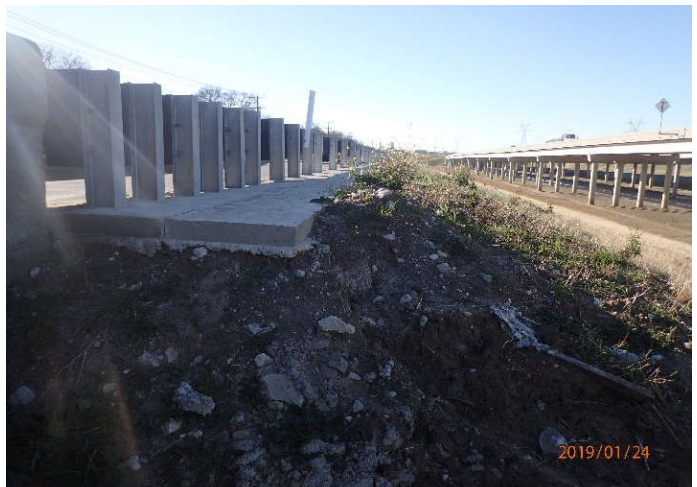
Figure 3: Erosion at Mow Strip at Walnut Creek Bridge

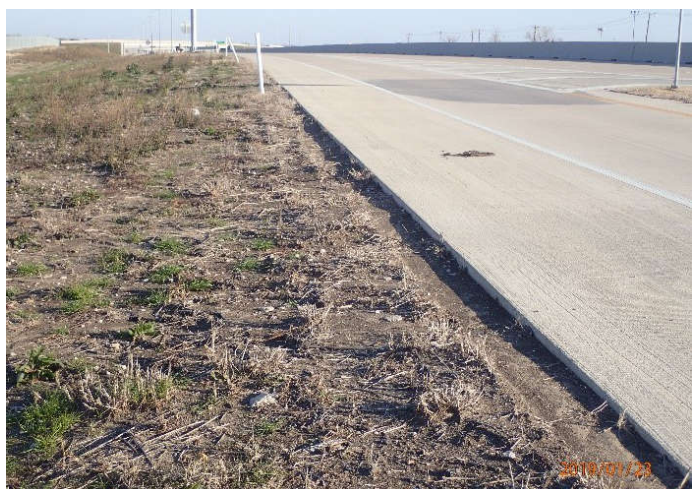
There are multiple isolated locations of pavement drop-offs (Figure 4). One location had missing pavement graphics (Figure 5).

Figure 4: Pavement Edge Drop-Off at SB Ramp to Holland Road

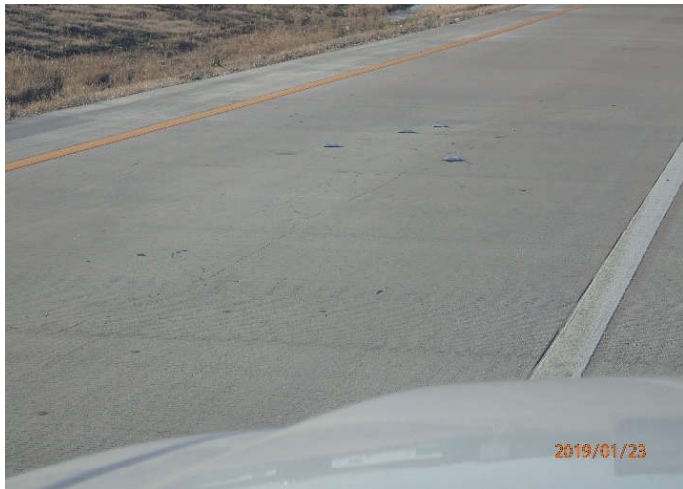
Figure 5: Missing Pavement Graphic (Arrow) SBFR at Broad Street

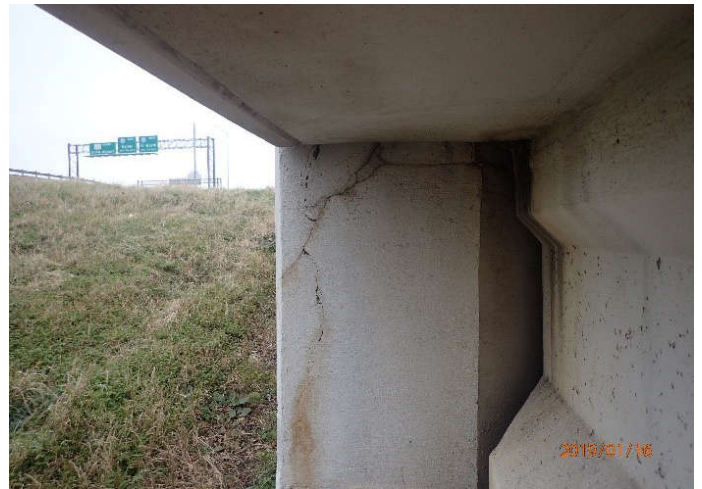
One observation noted was areas of backwall cracking as illustrated in Figure 8.

Figure 8: Backwall Cracking NB at Green Oaks

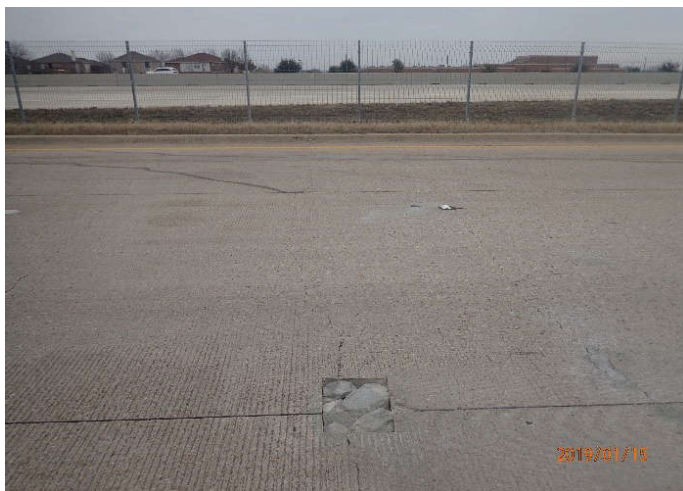
There were multiple areas of pavement cracking and spalling as illustrated in Figure 6. Some of these areas have been repaired (Figure 7).

Figure 6: Pavement Spall at Rock Hill Bridge

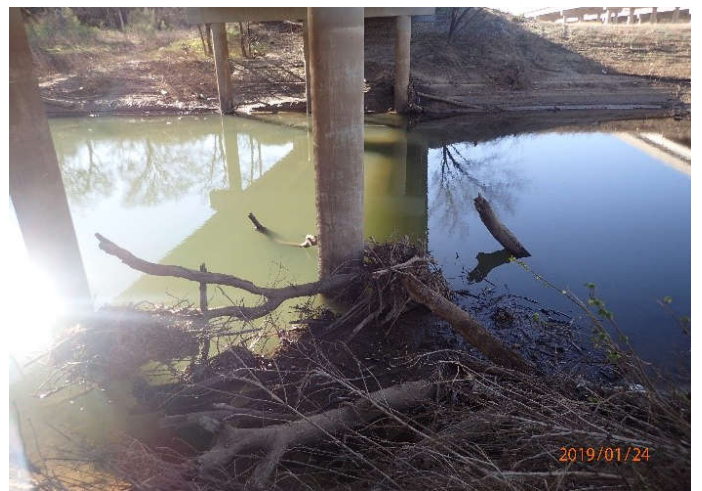
There was also noted an area where debris was building up against the bridge column (Figure 9).

Figure 9: Debris Against Column at Walnut Creek Bridge

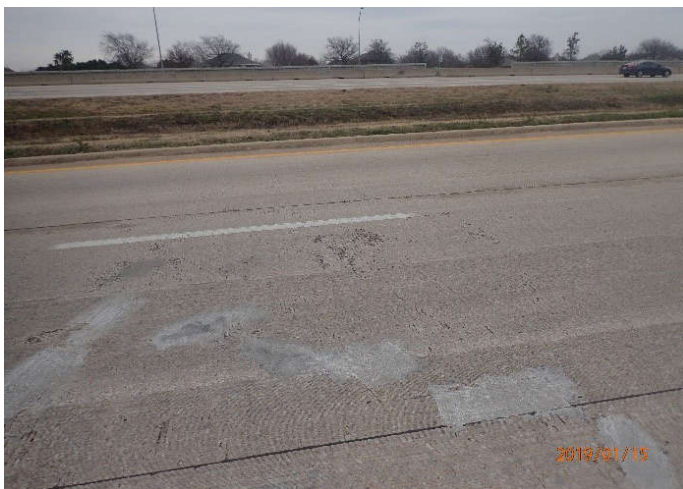
Figure 7: Pavement Spall Repair S of Green Oaks
